## **TECHNICAL MEMORANDUM**

**To:** Marisa Sowles, Geum Environmental  
**From:** Karin Boyd, Applied Geomorphology  
**Date:** October 28, 2020  
**Regarding:** Skalkaho Bend, Bitterroot River at Hamilton MT

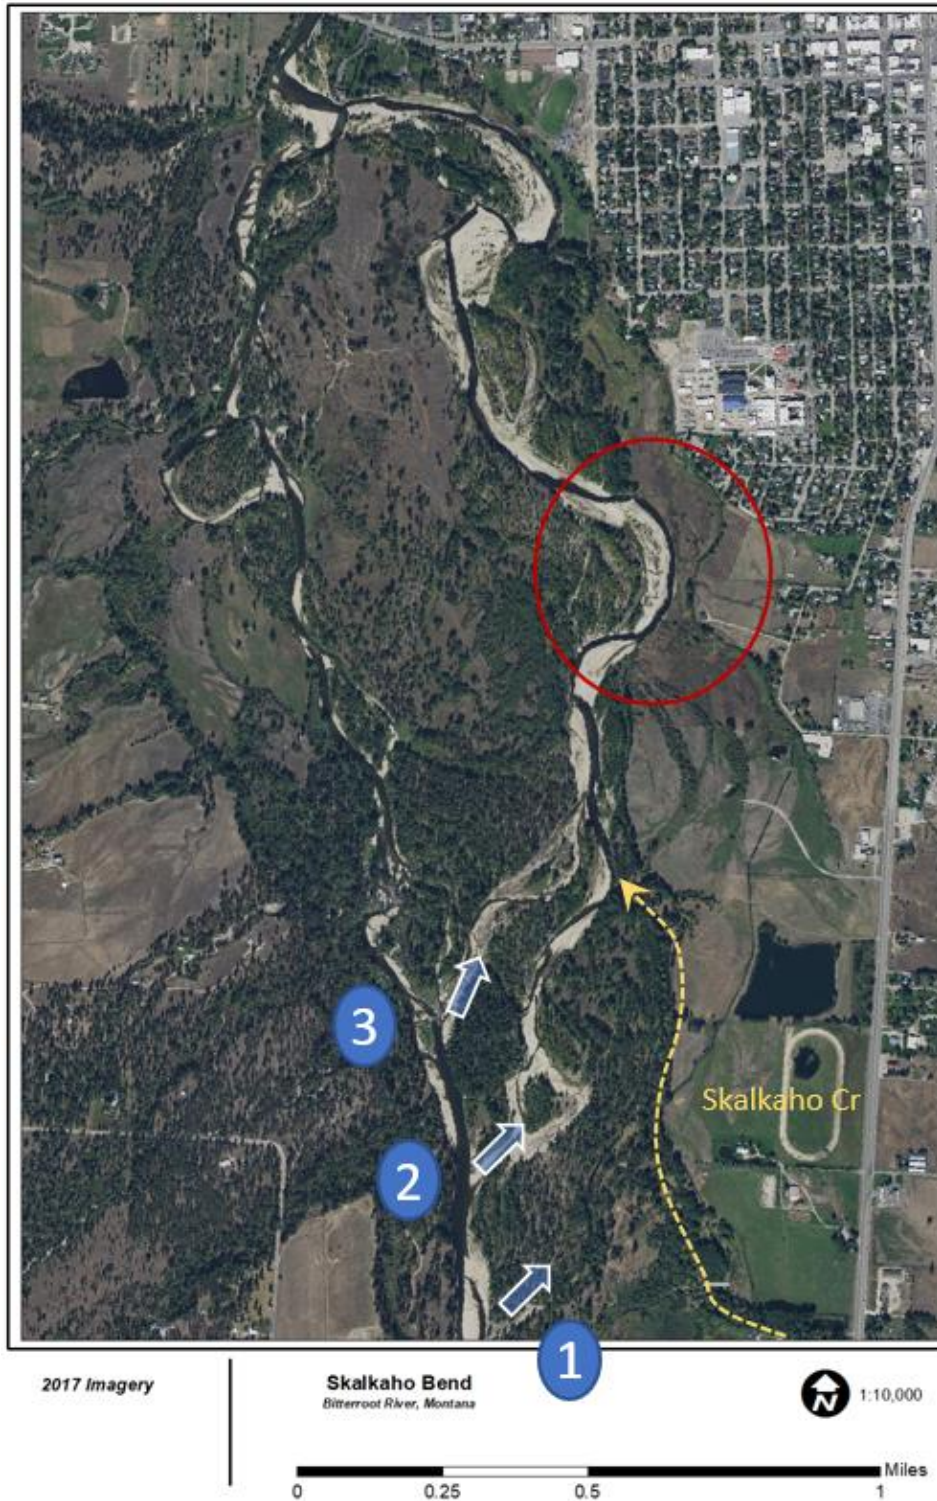
- The upstream-most flow split (#1) activates at high water and follows lowermost Skalkaho Creek, which will persist as a flow path to the eroding bank;
- The middle (#2) flow split has persisted and feeds a prominent high flow channel that routes water to the eroding bank;
- The lower (#3) flow split appears to be progressively shifting such that more water is going into the westernmost channel.

Figure 1. Prominent flow splits on Bitterroot River in 2017—bank of concern is marked by red circle.

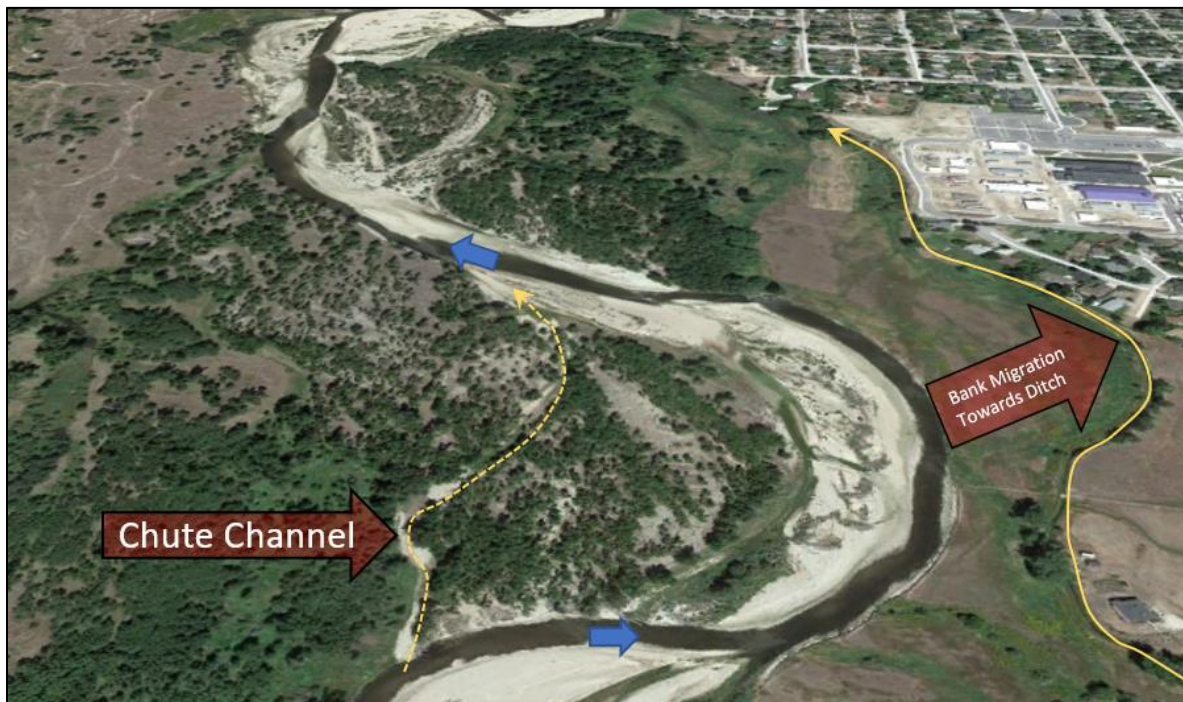
- There is a fully developed chute channel through the meander core that will likely continue to enlarge and convey progressively more flow in coming decades.

- The radius of curvature to width ratio of the eroding bend is about 3, which indicates that a wholesale cutoff is **not** imminent, and erosion will probably continue in the near-term.

Figure 2. Oblique image from Google Earth looking downstream showing Skalkaho Bend and ditch to right.

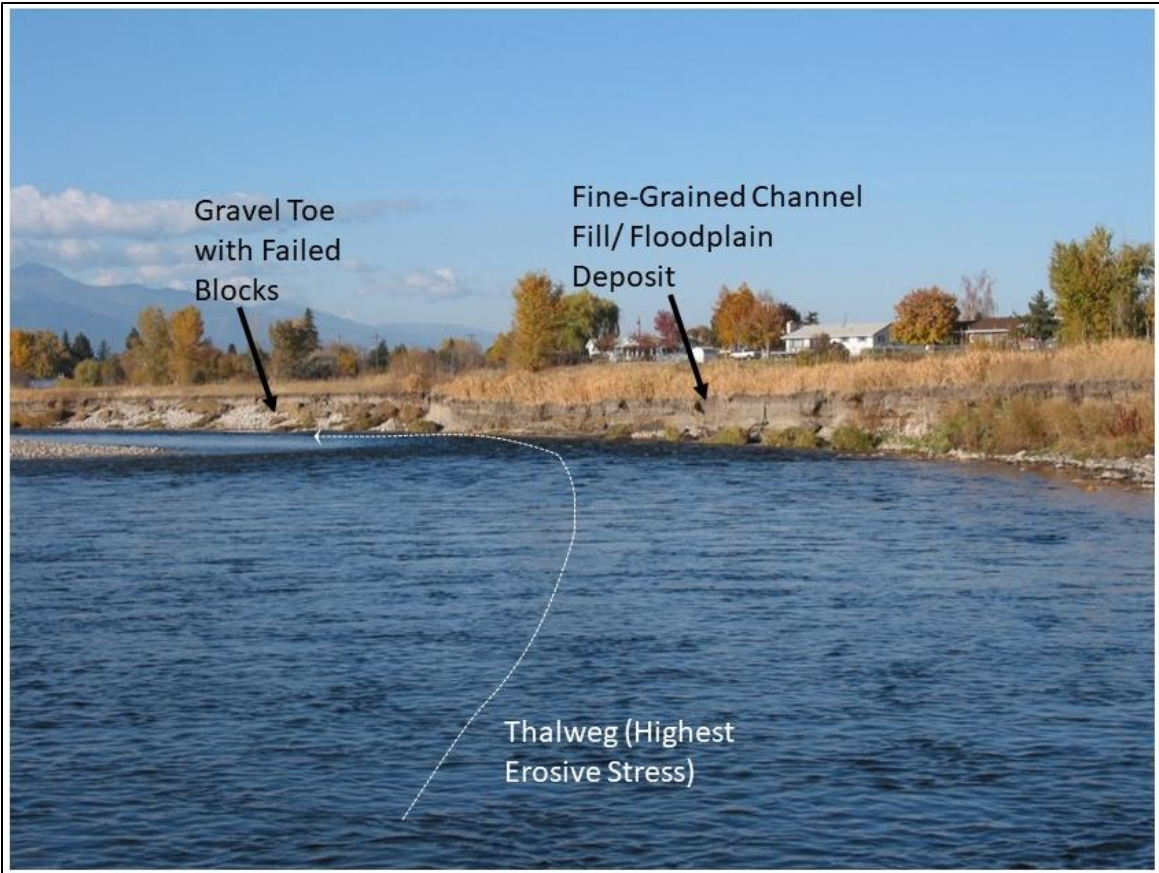
- The downstream portion of the eroding bank consists of a non-cohesive gravel toe that is overlain by fine grained floodplain deposits, whereas the apex of the bend has more cohesive swale/floodplain deposits (Figure 3). In general, the bank is quite erodible with topple failing upper banks that collapse with toe erosion. The photo in Figure 3 was taken during a field inventory of the river in 2002.

Figure 3. Eroding bank at Skalkaho Bend as photographed in 2002.

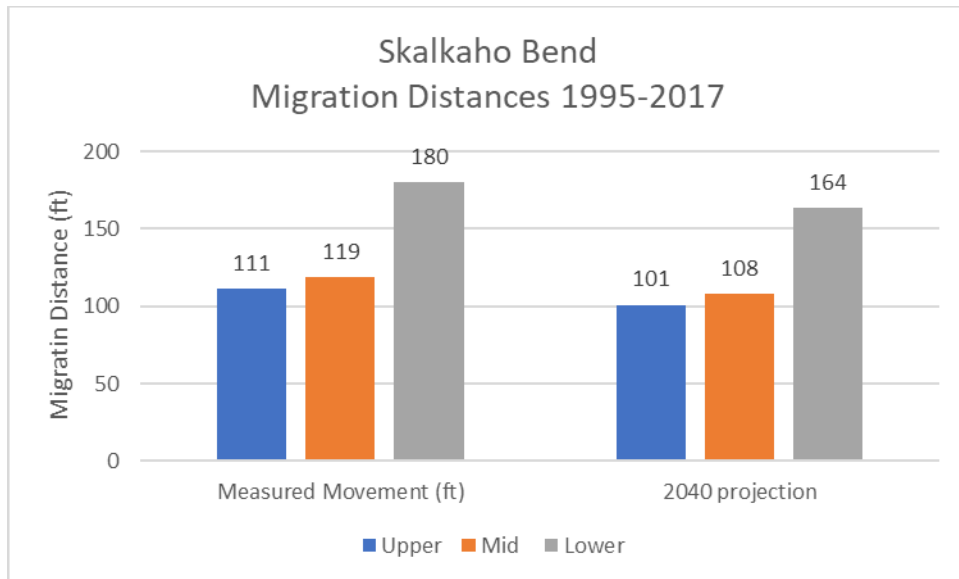
- Like most bendways, the erosion is fastest on the downstream portion of the bend. Since 1995, the upper limb of the meander has migrated about 110 feet, whereas the downstream limb has shifted about 180 feet (Figure 4).

- Continued migration of the bend may result in its interception with a prominent ditch that follows the edge of town and Rocky Mountain Laboratories; based on historic rates this will happen in about 20 years (Figure 4). This projection is based on **average** migration rates; it is important to note that long duration flooding and changes in upstream flow splits could drive higher rates of bank retreat. Since 1995, the USGS gage near Darby (#12344000) has recorded no events over a 10-year flood (Table 1).

Figure 4. Migration distances on eroding bend (left) and projected movement through 2040 (right).

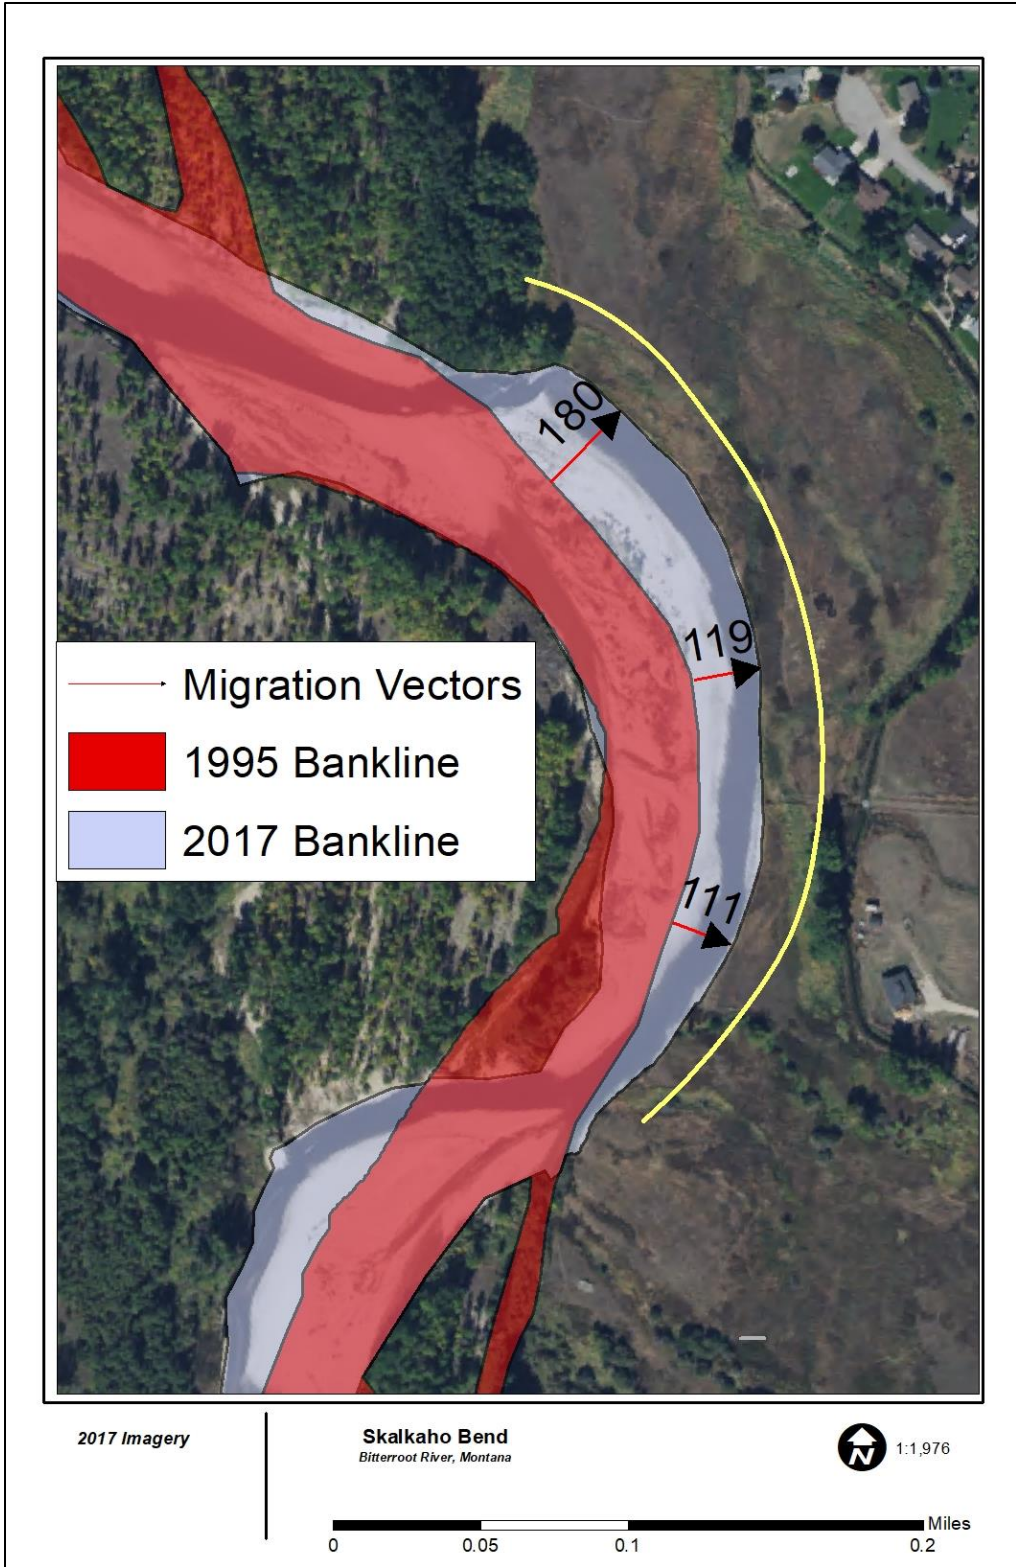
Figure 5. Measured 1995-2017 migration distances along bend showing estimated 2040 bank location (yellow) based on average annual erosion rates.

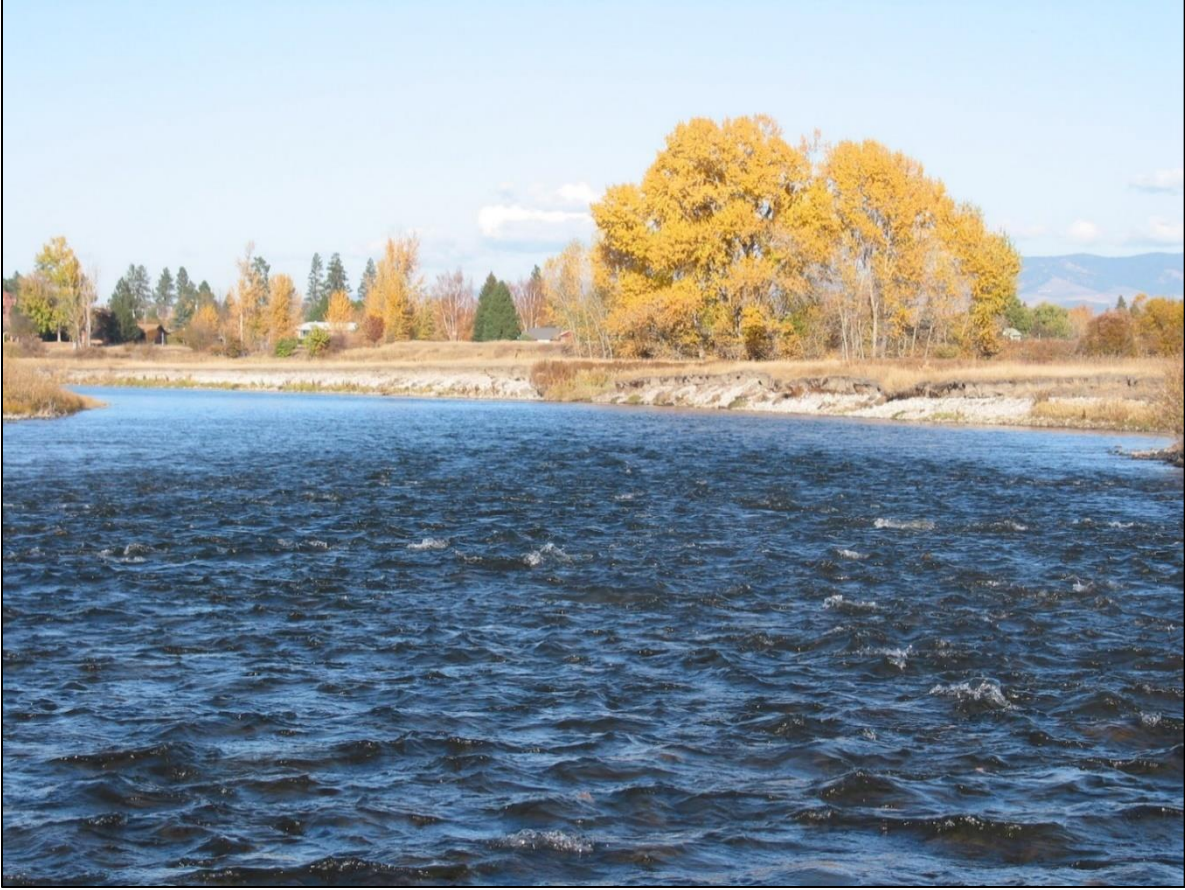
Figure 6 shows a view downstream of the upper part of the bend in 2002; at this point the river was about 200 feet from the edge of the cottonwoods and the ditch; in the 2017 imagery it is about 130 feet away.

**Figure 6. View downstream from 2002 showing cottonwood grove along ditch line.**
